Trail Creek Watershed Analysis

Bureau of Land Management
Medford District, Oregon
June 1999

TRAIL CREEK WATERSHED ANALYSIS

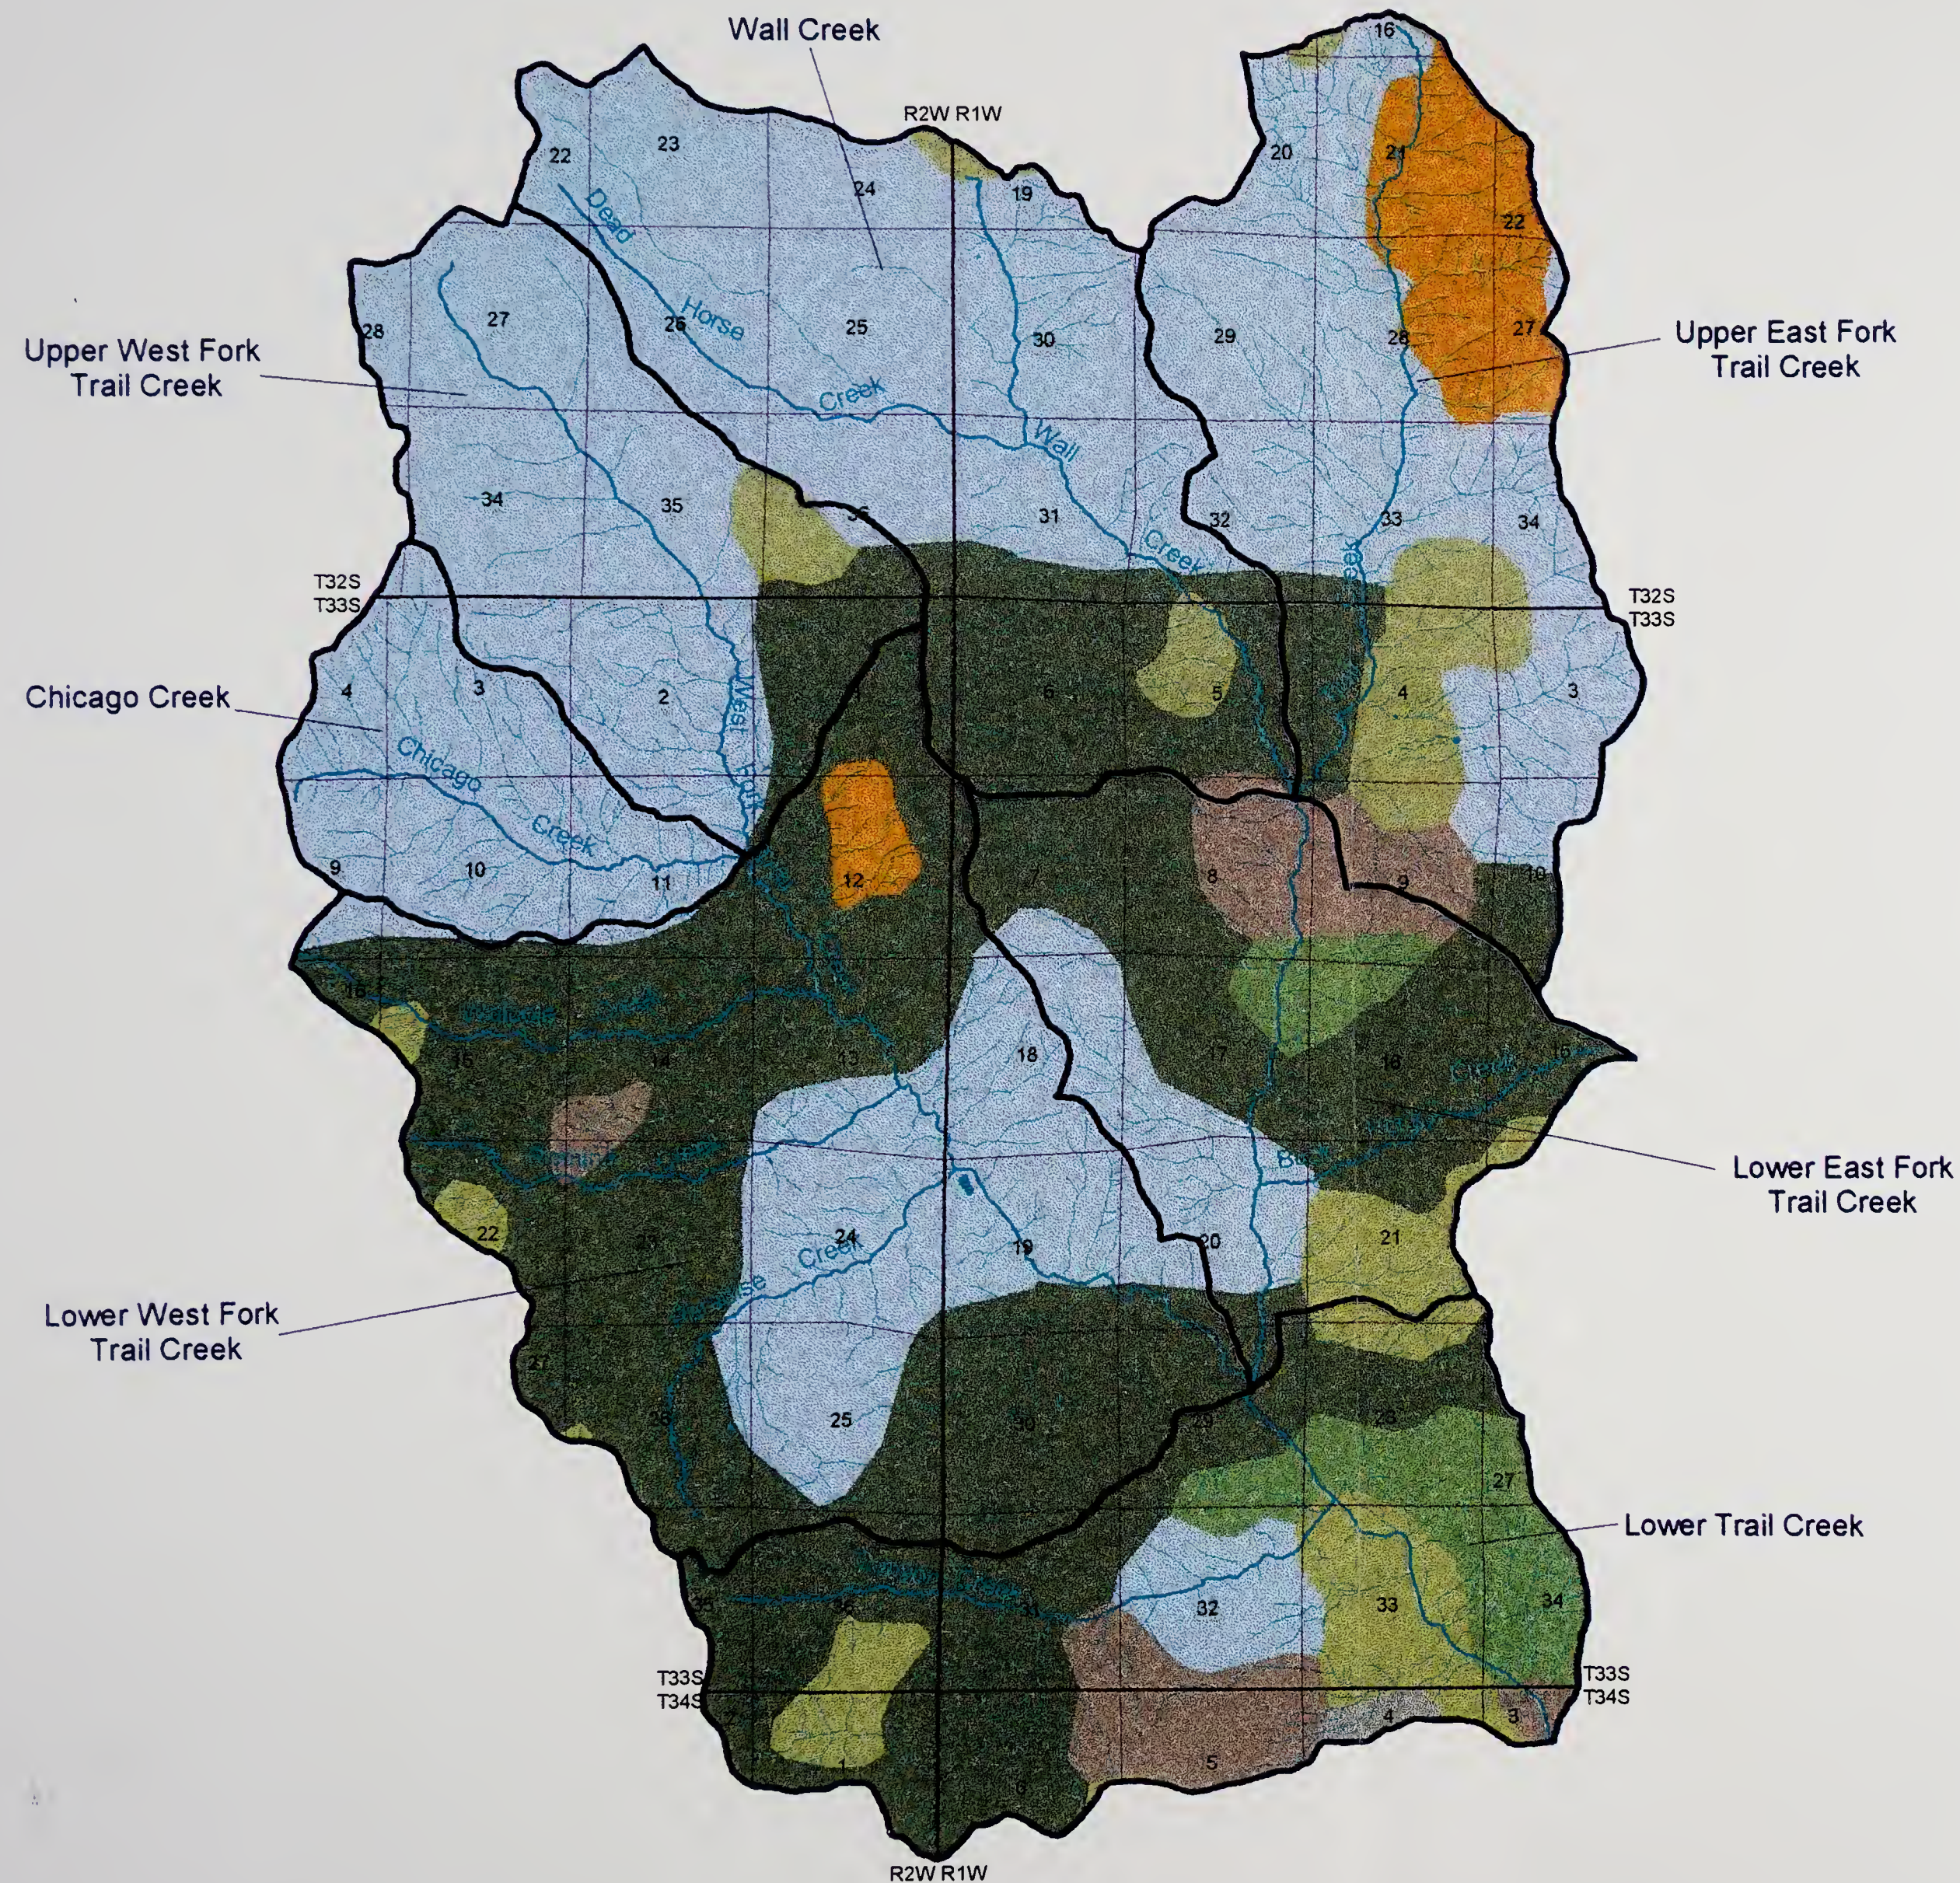
Historic Vegetation - circa 1936
Trail Creek Watershed Analysis
Medford District BLM
FIGURE 3-14

- Non-Forest
- Deforested Burns
- Hardwood
- Conifer - Seedling/Sapling/Pole
- Conifer - Small Timber
- Conifer - Large Timber
- Conifer - Old Growth
- Sub-Watershed Boundary

tributaries, was forested. A significant amount of timberless area did exist, however, in the lower watershed extending almost half way up the West and East Forks of Trail Creek. Information from 1936 (see Figure 3-14) reveals that timber and land conversion extended open conditions somewhat further up the watershed. Historically, both forks of Trail Creek along their upper reaches, and their tributaries, were more heavily shaded than they are currently. In the lower portions of the drainage, however, the effect of current stream shade on stream temperatures appears to be comparable to historic conditions.

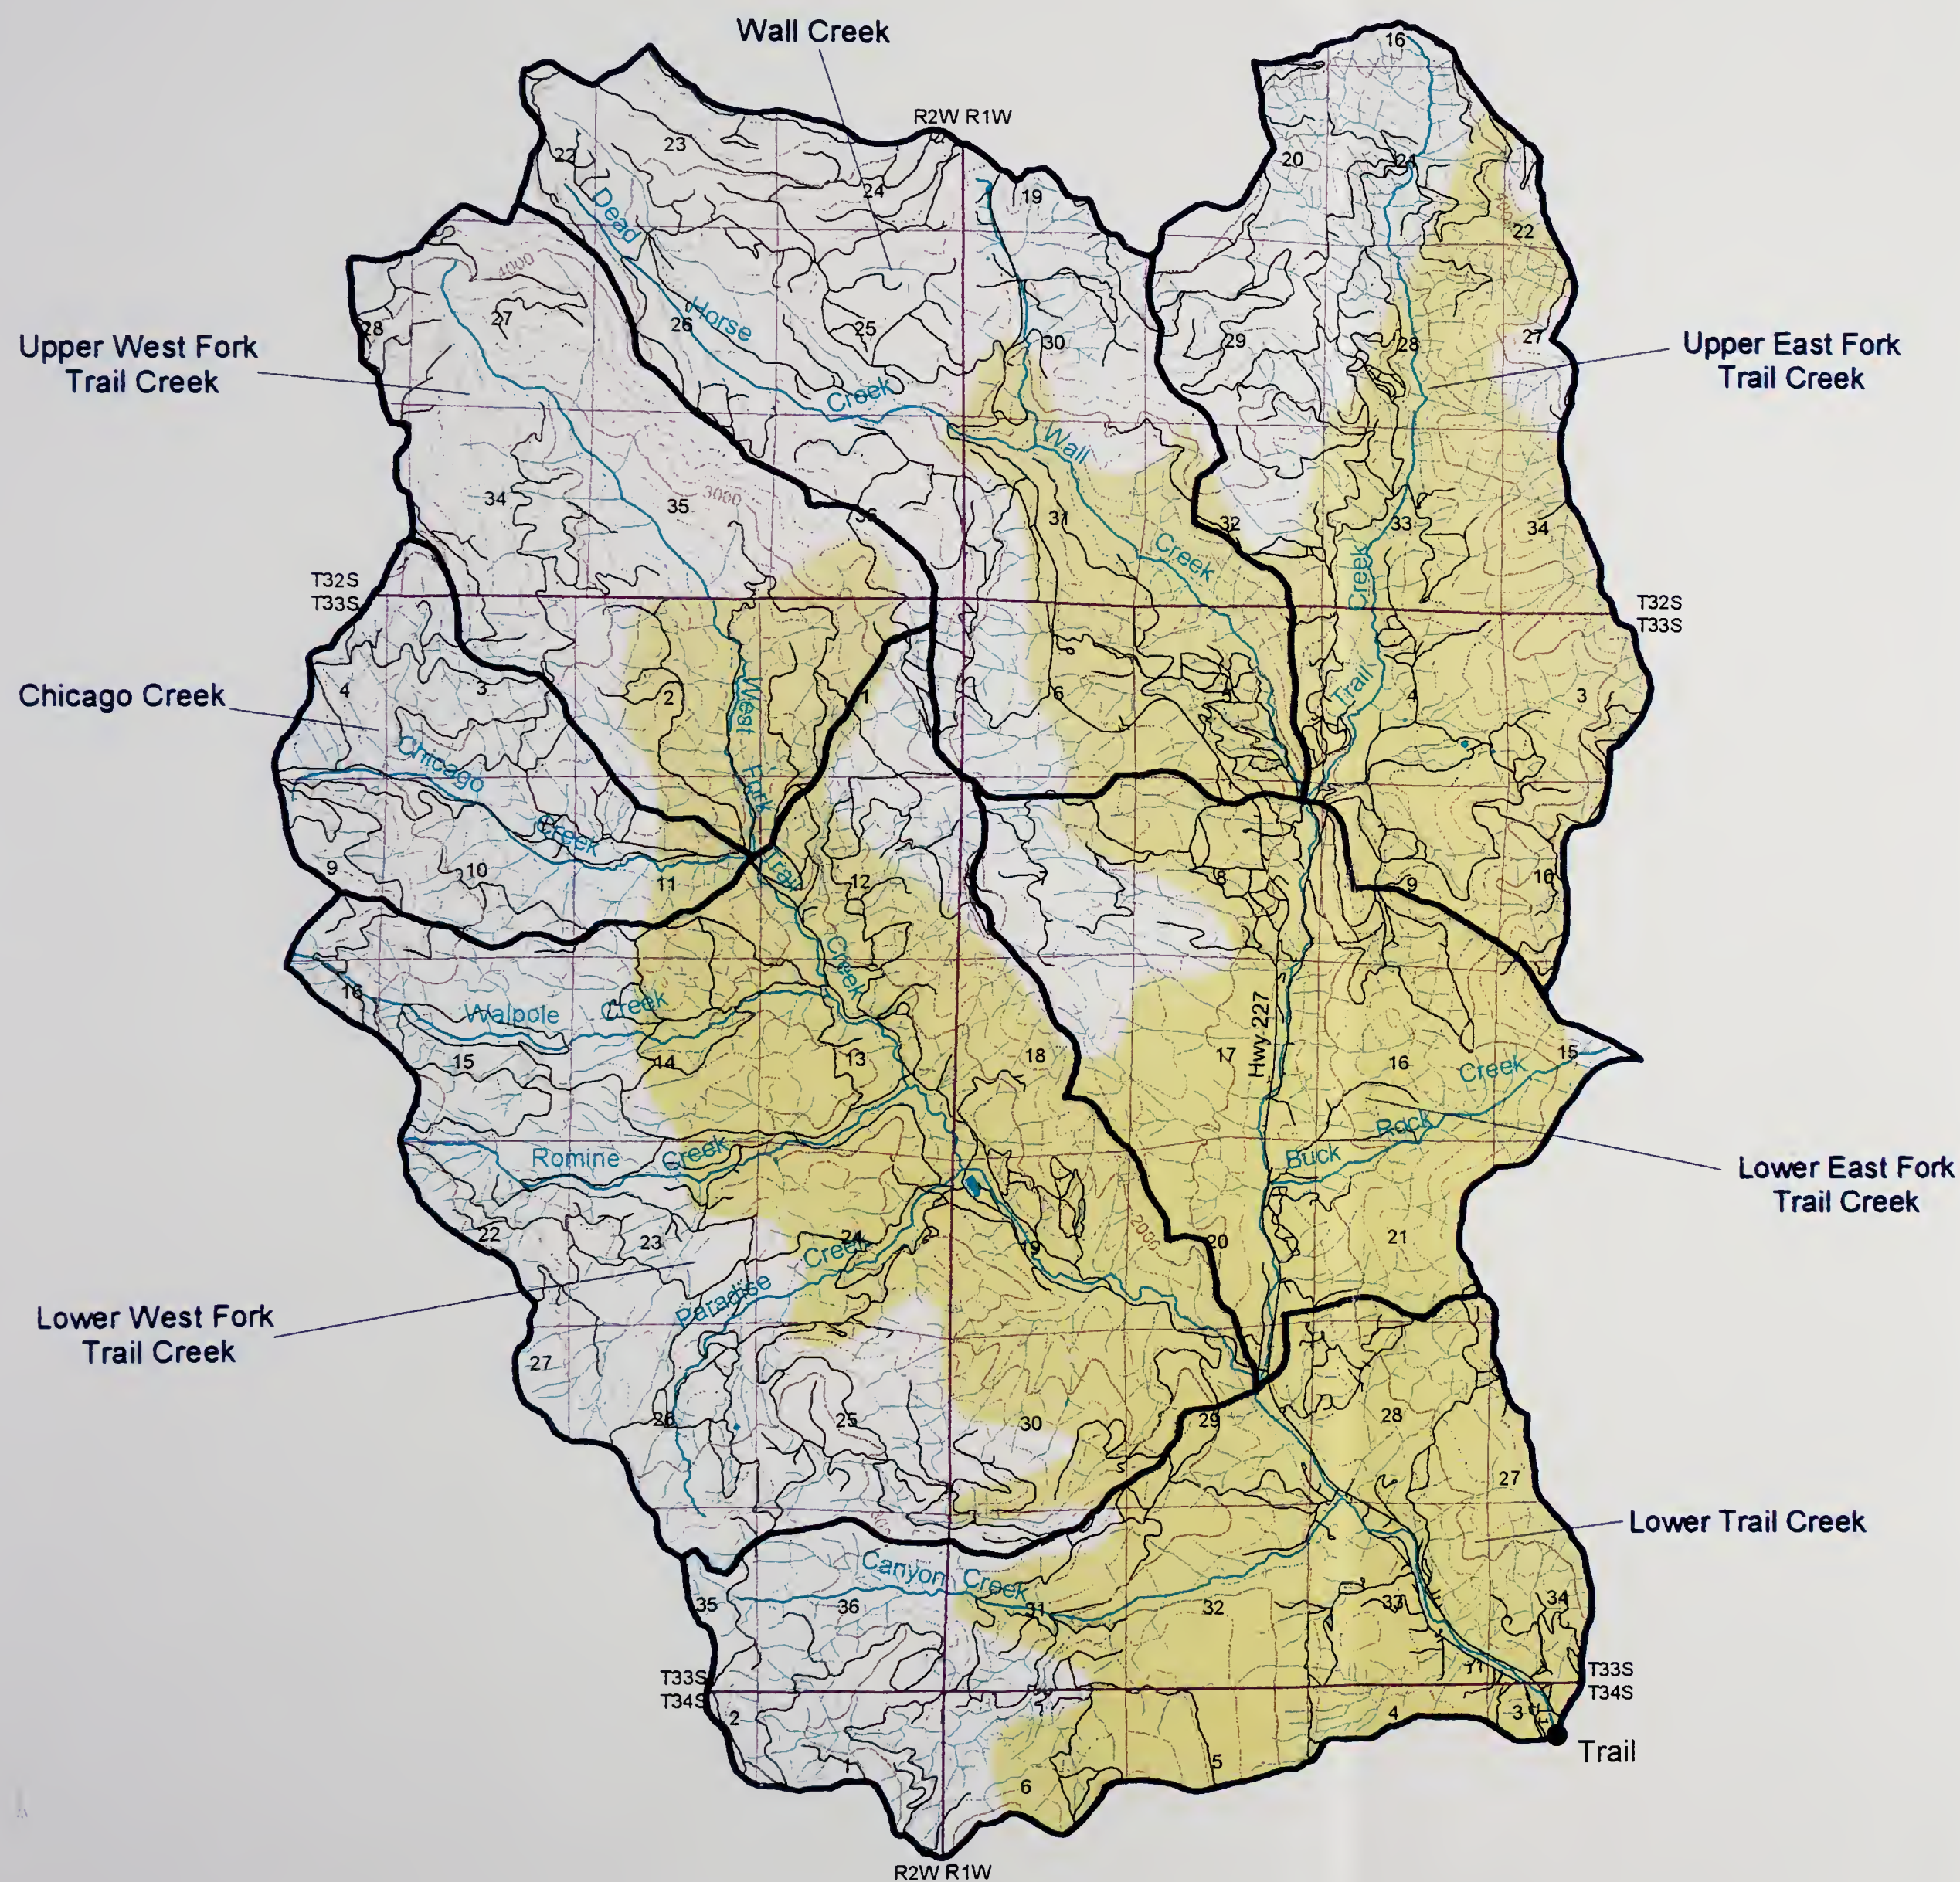
Critical Habitat Units
Trail Creek Watershed Analysis
Medford District BLM
FIGURE 3-23

The U.S. Fish and Wildlife Service has designated spotted owl critical habitat, pursuant to the Endangered Species Act of 1973 (Federal Register, 1992, vol. 57:10, p. 1796) (Figure 3-23), however, this land use designation was not carried forward in the Northwest Forest Plan. Clarifications related to this designation can be found in Appendix G. There are about 4,936 acres of critical habitat designated within the watershed. Of designated critical habitat, about 28 percent is nesting habitat (BLM Classification), 34 percent is unsuitable habitat, and about 38 percent does not fall into one of the previous categories.

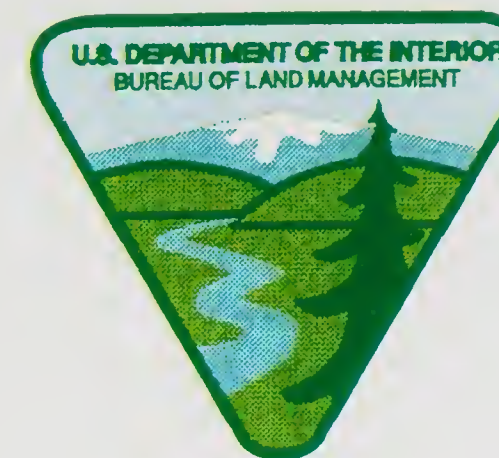
Deer Winter Range
Trail Creek Watershed Analysis
Medford District BLM
FIGURE 3-24

Studies initiated by the Oregon Department of Fish and Wildlife in 1995 indicate that deer migrate from long distances to winter in the watershed. Approximately 18,205 acres of the watershed are utilized by wintering black-tailed deer (Figure 3-24). Deer winter at lower elevations where snow does not become too deep, but also utilize old-growth stands at higher elevations. Mature and old-growth forest communities often accumulate less snow on the ground and produce lichens, which fall from tree trunks and branches, providing important winter food for deer. Like elk, black-tailed deer forage in clear-cuts less than 20 years old and seek cover in late seral forests

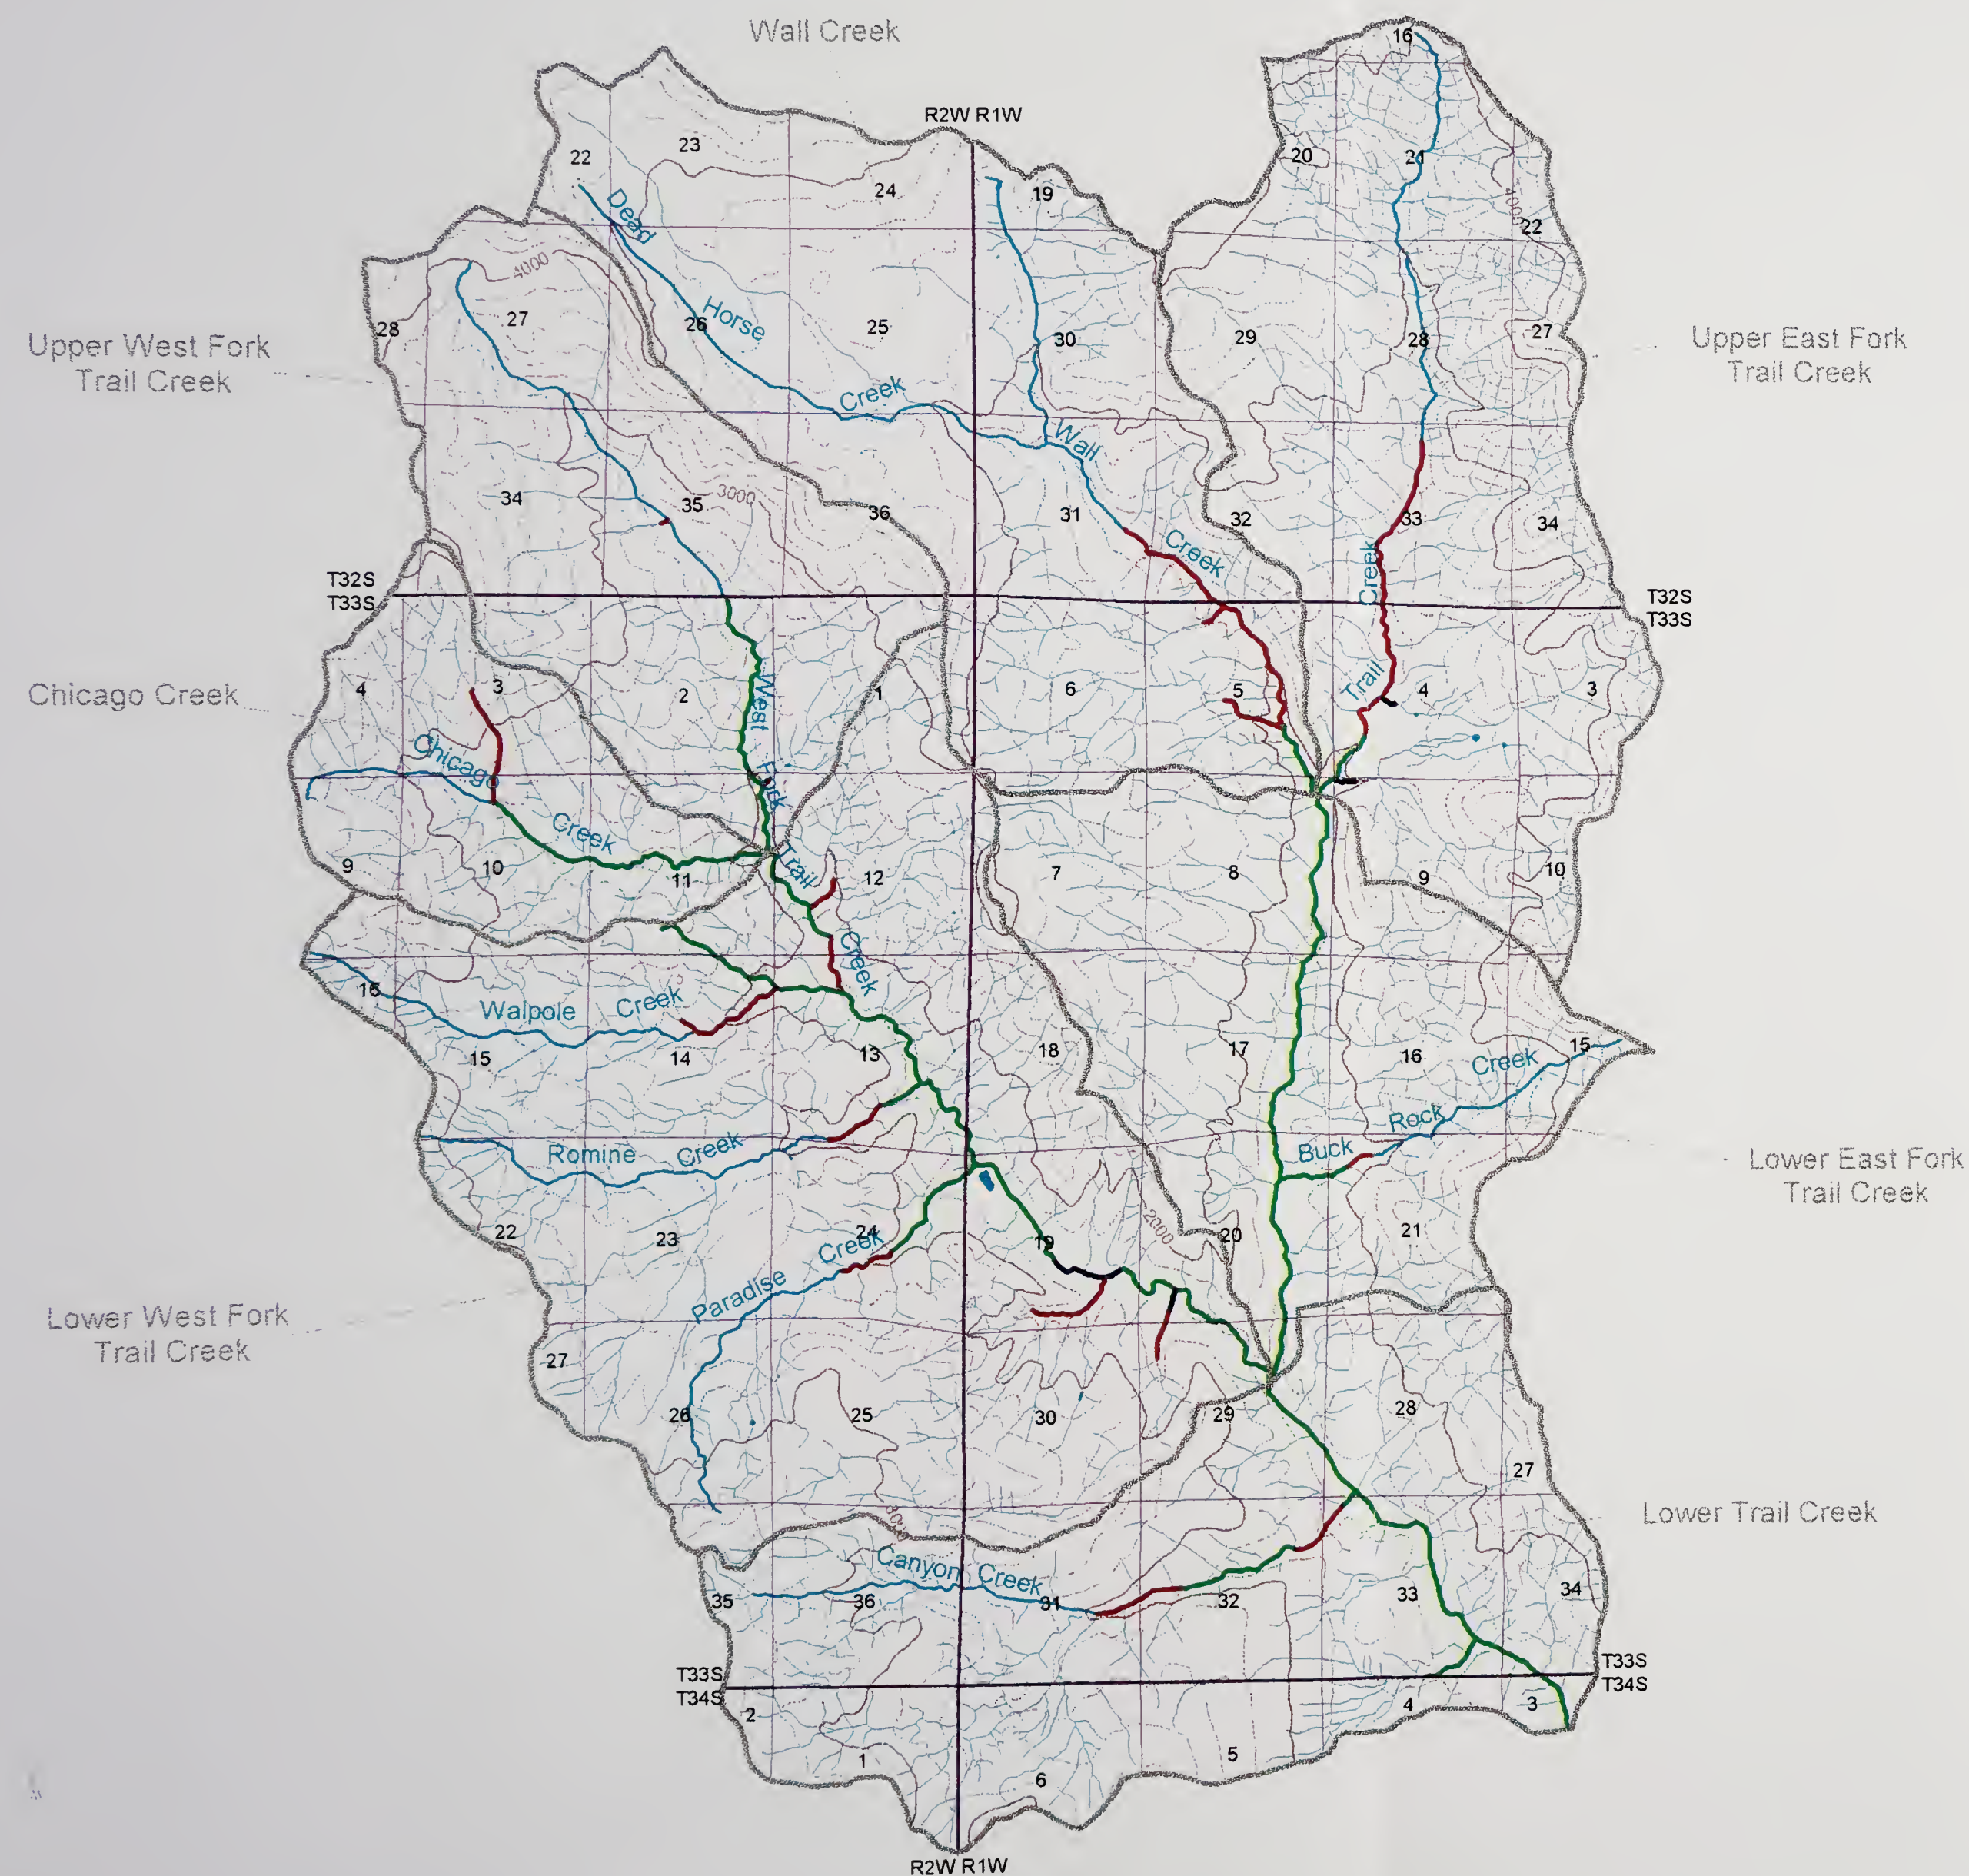
- Low
- Moderate
- High

Large Woody Debris Recruitment Potential
Trail Creek Watershed Analysis
Medford District BLM
FIGURE 3-25

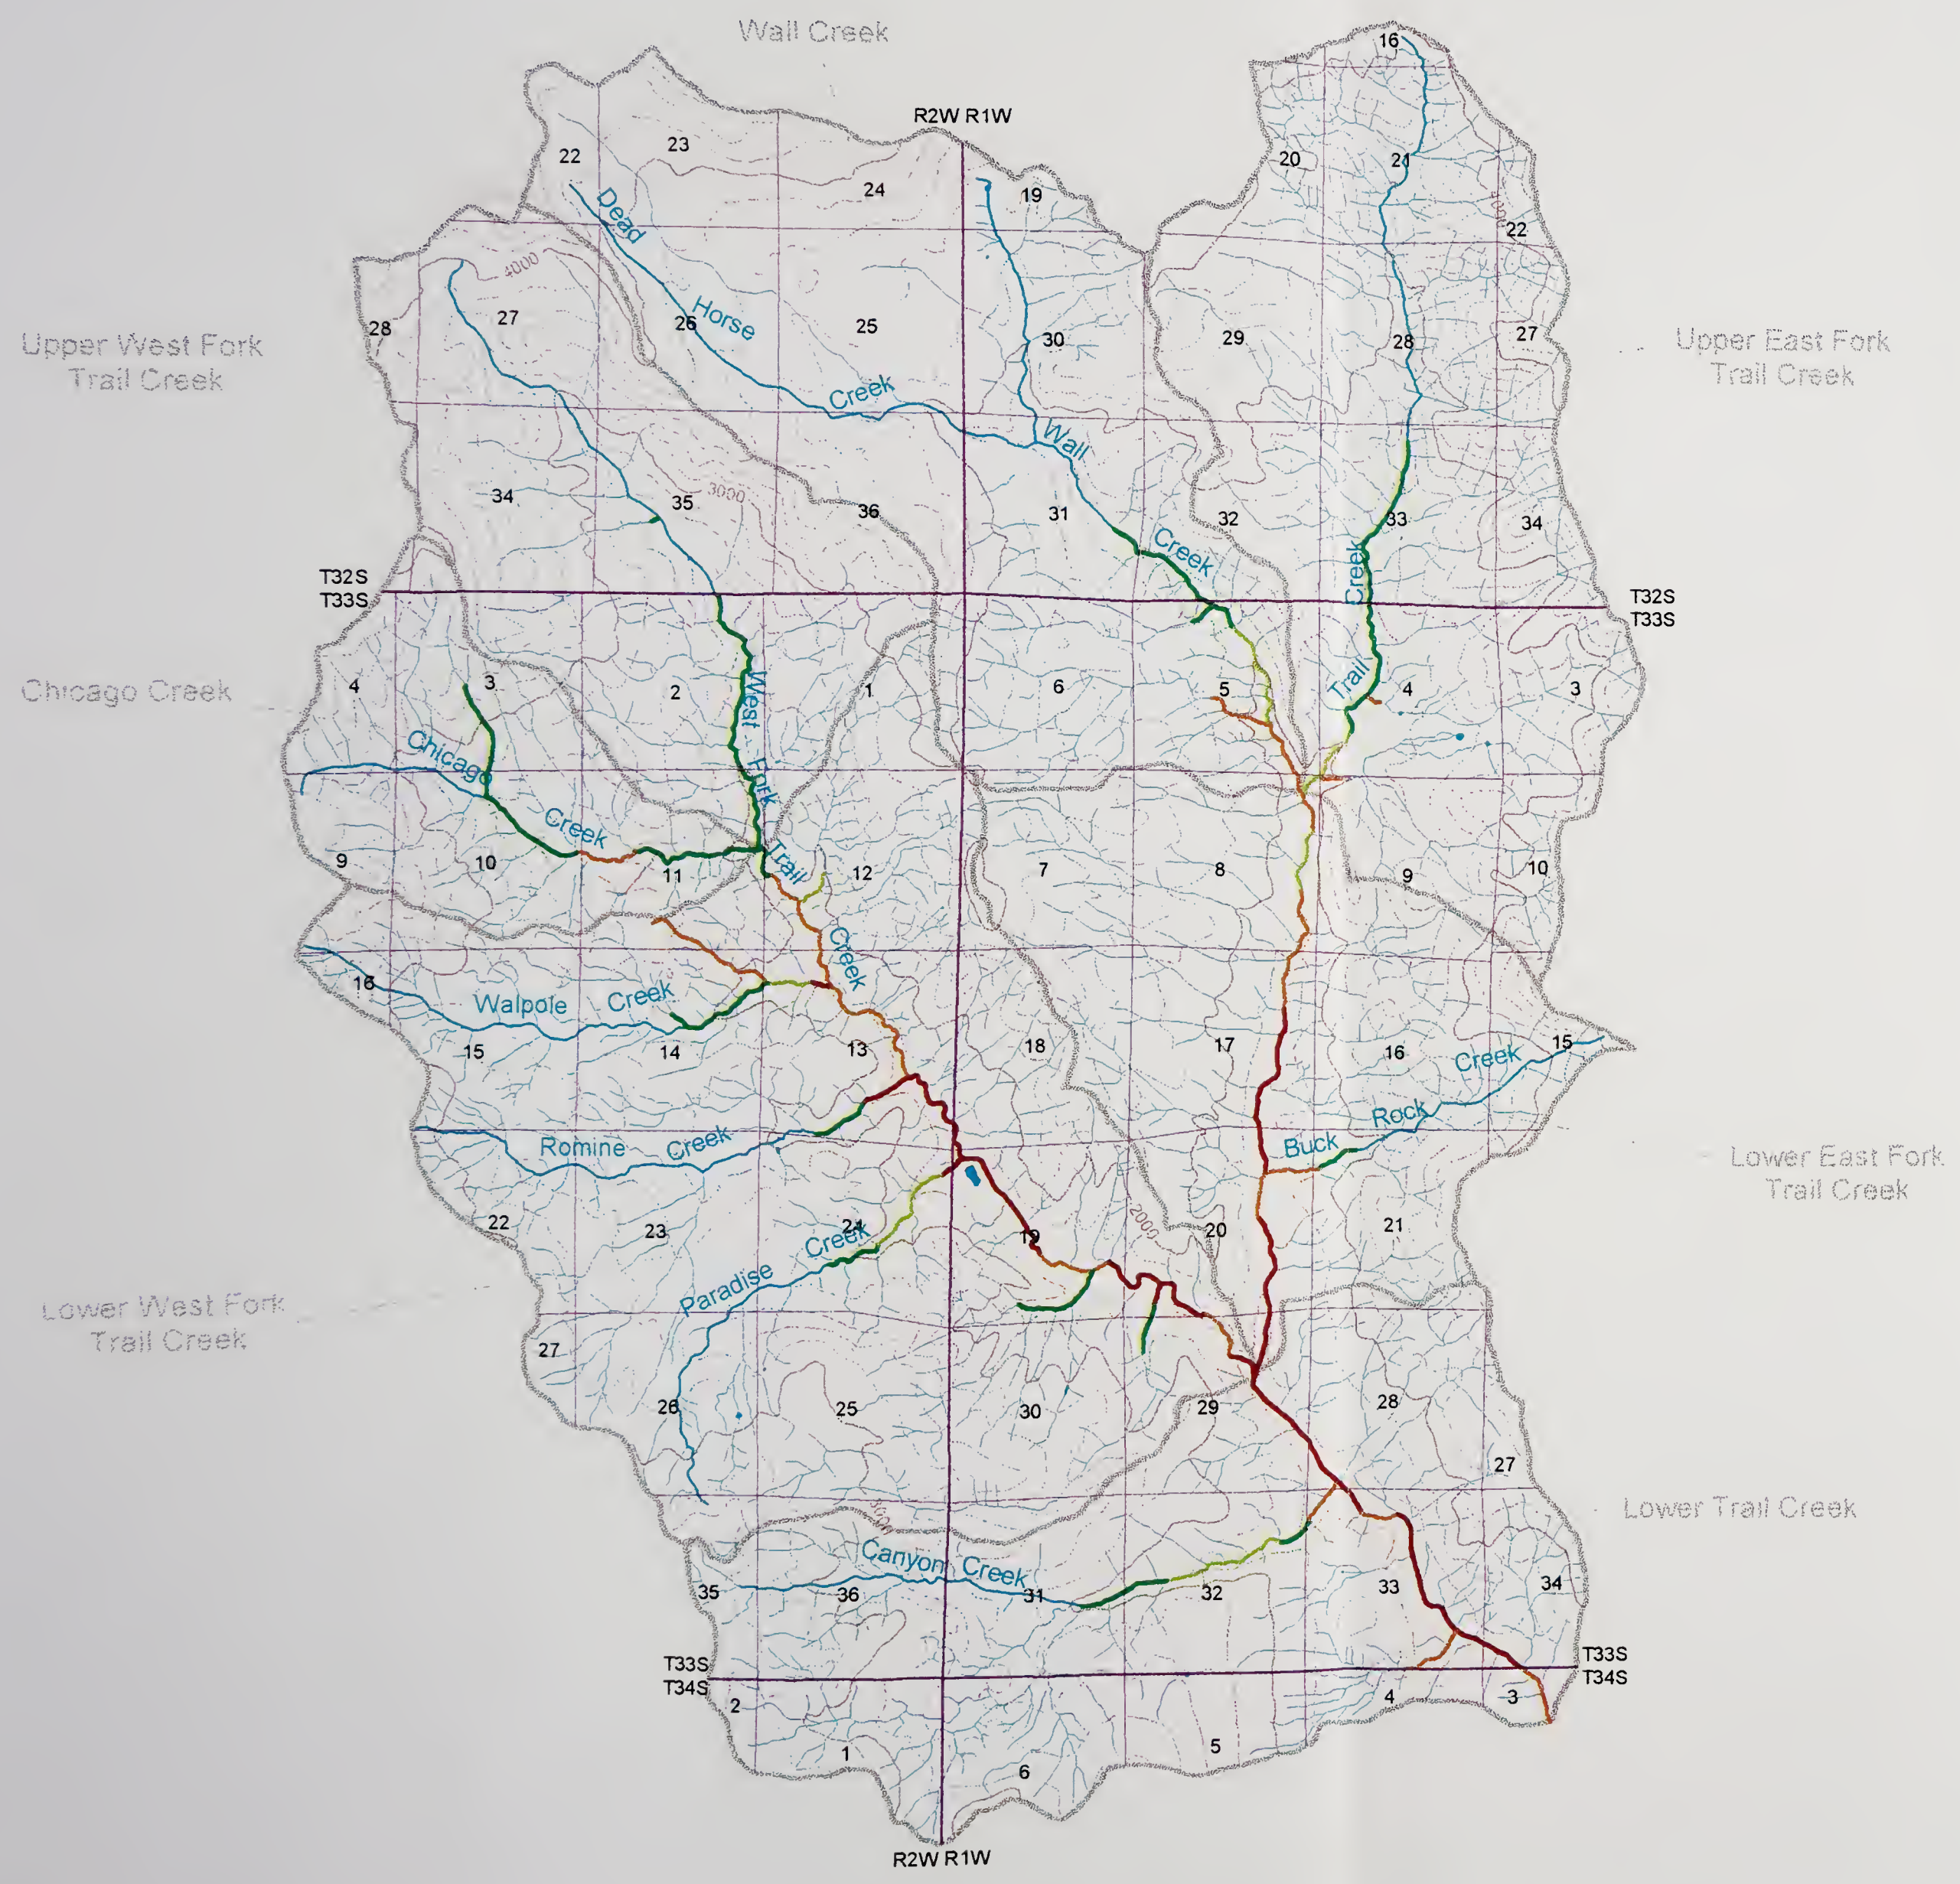
Tables 3-17 and 3-18 list the riparian stand conditions and associated miles of low, moderate, and high recruitment potential for LWD on federal and private lands, respectively. Figure 3-25 indicates the locations of LWD recruitment potential. As Table 3-18 indicates, approximately 78% of the streams on federal lands have high or moderate LWD recruitment potential. Conversely, Table 3-19 indicates about 80% of fish-bearing streams on private lands have low LWD recruitment potential. Combined, this indicates that about one-third of fish-bearing streams have viable near-term LWD recruitment potential. Overall, this reflects the ownership pattern and forest vegetation conditions in the lower part of the watershed.

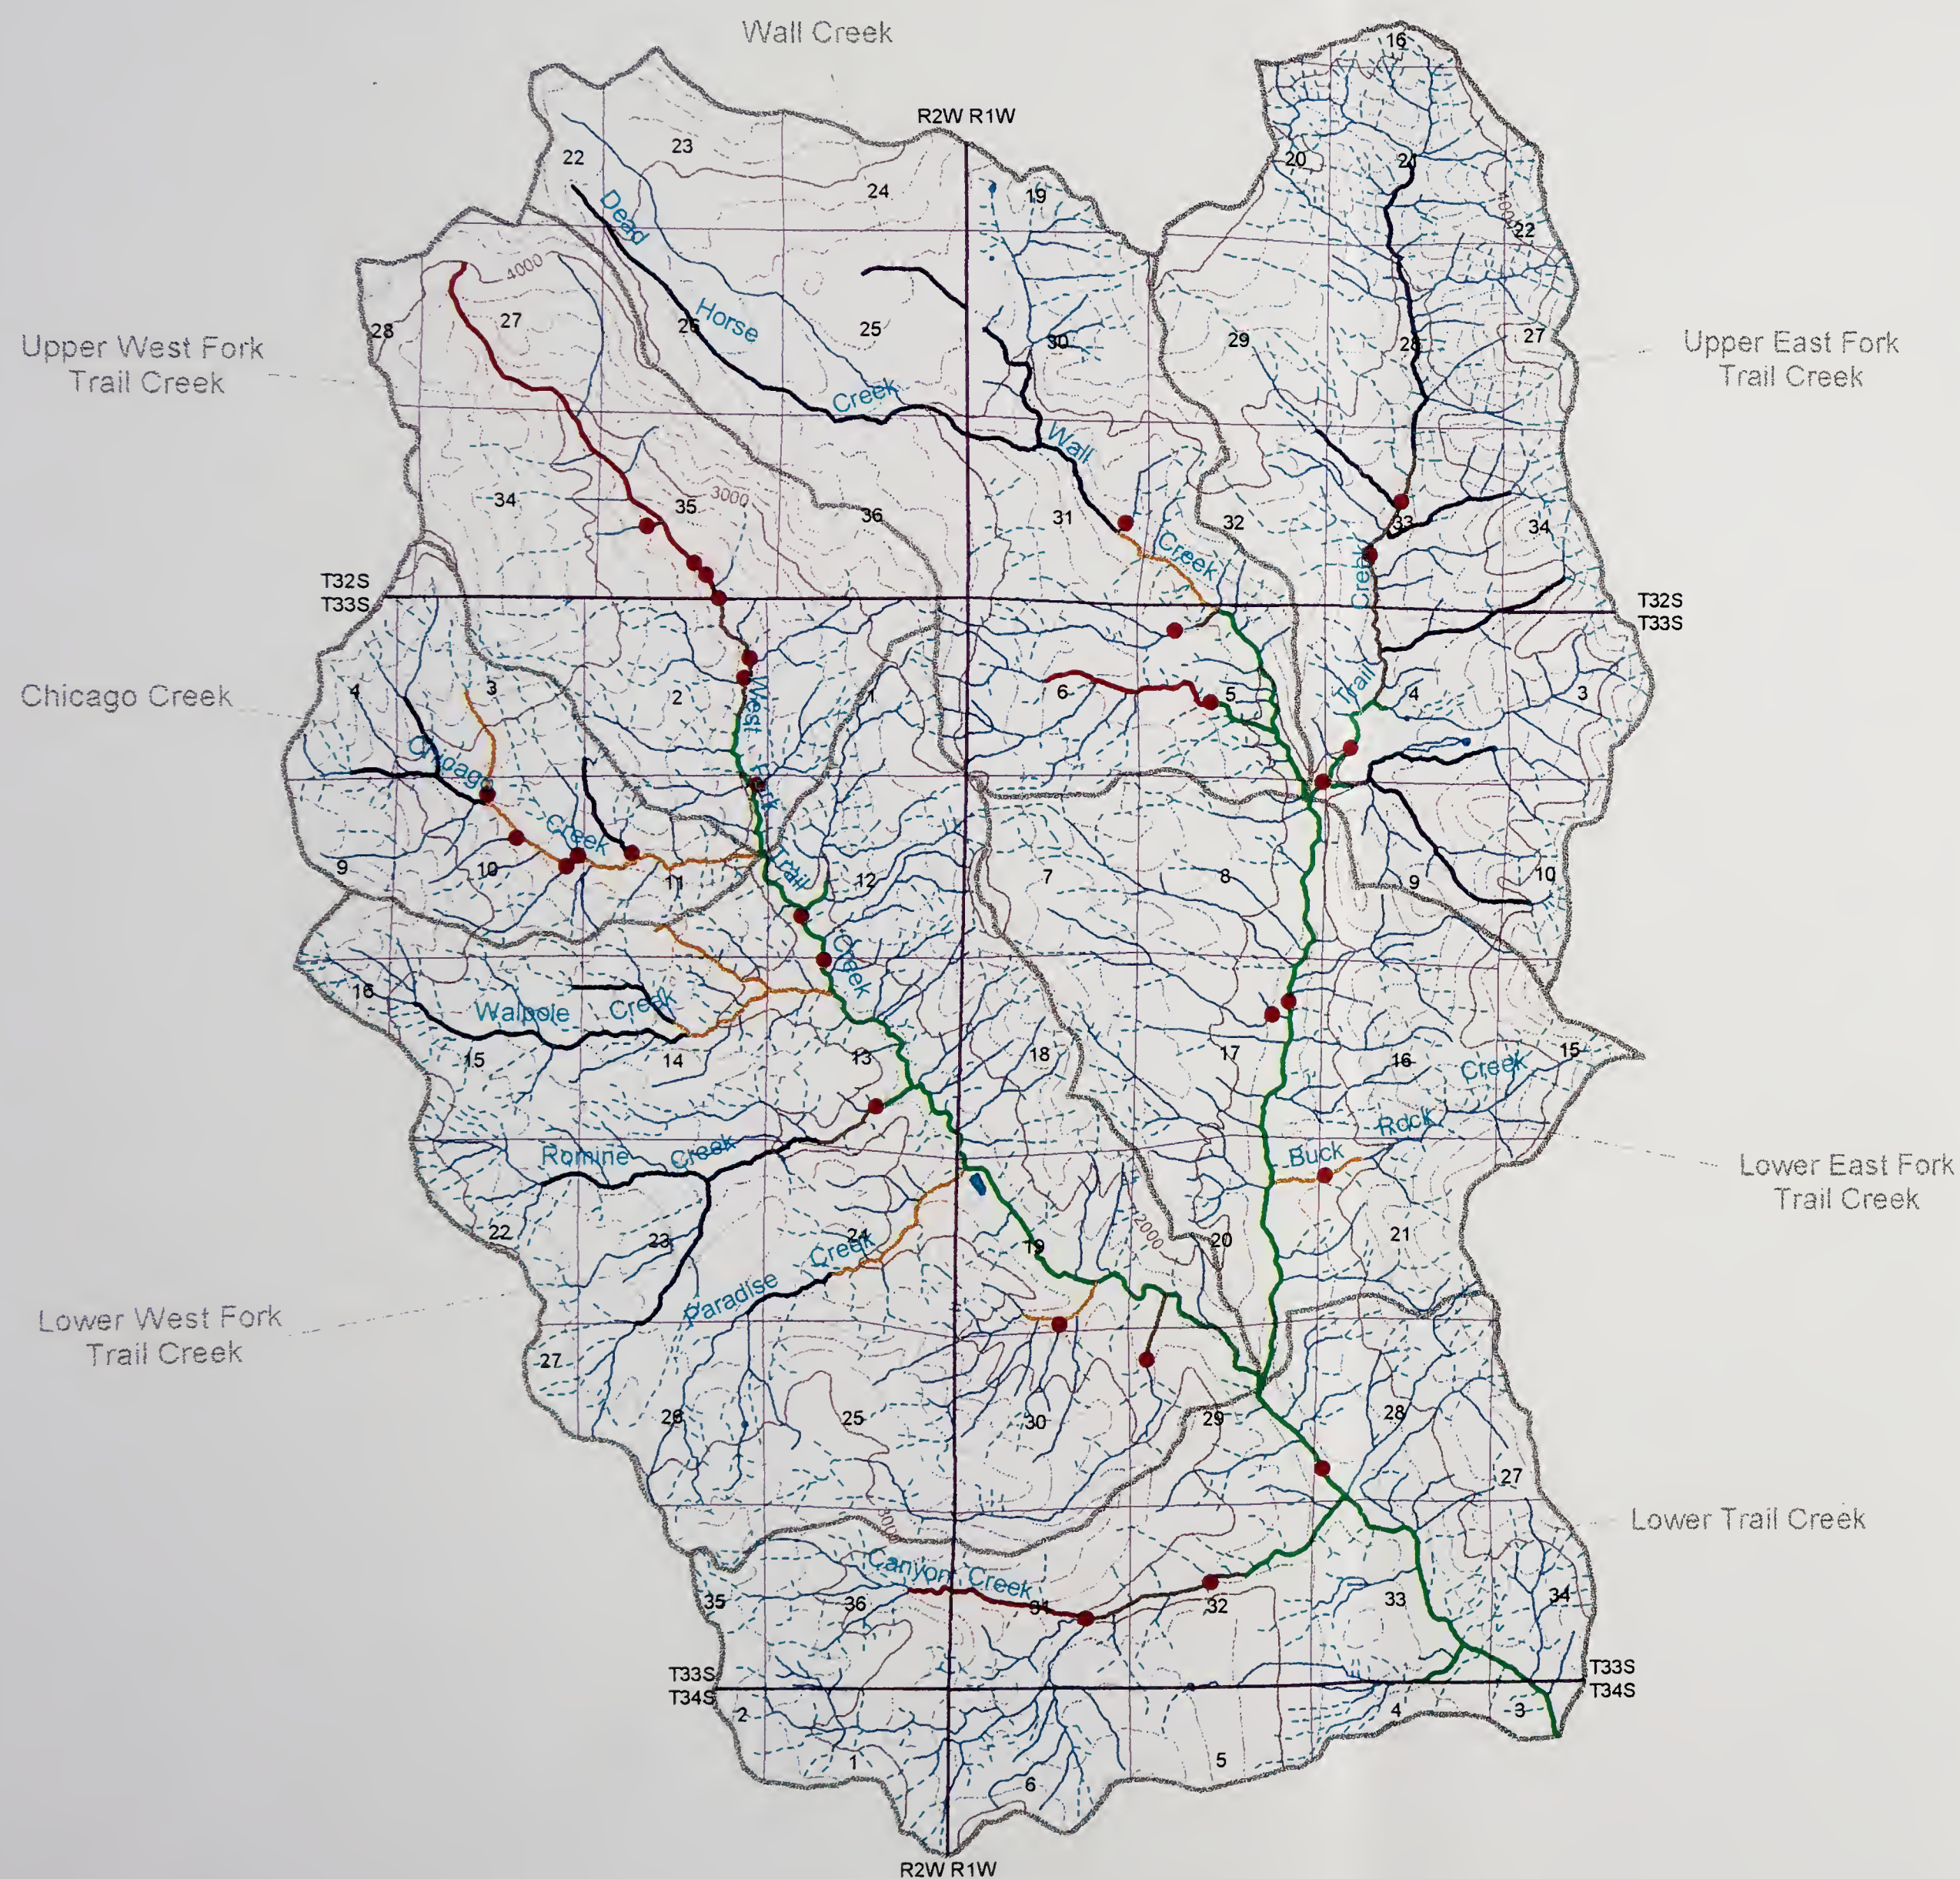
Stream Shading Classes
Trail Creek Watershed Analysis
Medford District BLM
FIGURE 3-26

Tables 3-19 and 3-20 list the miles of stream at various shading levels within the riparian zones on federal and private lands, respectively. Figure 3-26 identifies where these areas are found within the watershed. The effect of stream shade on stream temperatures was evaluated (see Temperature discussion below) and indicated that almost all of the stream miles in the Trail Creek watershed have a high shade hazard, that is, the existing shade levels are less than that required to maintain stream temperatures below the 64 degrees F Oregon standard. This is largely a reflection of the relatively low amounts of adequate shade in the lower portions of the watershed. Only 5.86 miles (or 21%) of the fish-bearing streams currently provide 80% shade cover or greater. Overall, this finding indicates a shade-deficient condition predominates, however, it must be noted that the effect of this condition on stream temperatures must be supported by actual temperature monitoring data.

Fishery habitat values for streams in the watershed are correlated with features such as: temperature, frequency, depth, and gradient of pools; width/depth ratio, particle size, substrate geology, and gradient of riffles; amounts of gravel; amounts of large woody debris in streams; and large trees within 30 meters of the channel. In general, streams in the watershed have favorable ratings for pool areas, active channel widths per pool, and amounts of bank erosion. Based on physical characteristics, habitat values in the Trail Creek watershed are sub-optimal due to limited amounts of spawning gravel and large amounts of fine sediment in spawning gravel. Sub-optimal amounts of large woody debris (Figure 3-25) in and adjacent to the stream channel, insufficient shade (Figure 3-26), and high water temperatures (Figure 3-12) significantly limit habitat quality in the watershed.

spawning gravel and high summer water temperatures appear to be important habitat deficiencies. Low amounts of shading at lower elevations of the watershed (Figure 3-26) allow water temperatures to exceed 64 degrees, the ODEQ standard.
